Automated shuttles in a residential area

Video observations of interactions with other road users in Ski - Hebekk

1917/2022

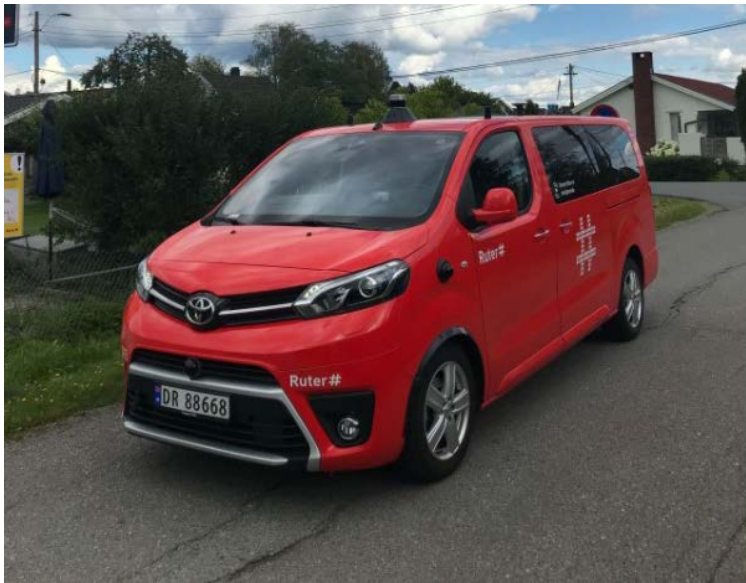
Figure 1.2: The retrofitted automated Toyota Proace van (photo: TØI).

There were two Toyota Proace vans (hereafter referred to as “shuttles”, see Figure 1.2) in service on this route and they drove 20 248 km in total during the project. The shuttles were retrofitted with Autonomous Drive System (ADS) technology from the Sensible4 company. One such shuttle can accommodate 4-6 passengers plus a driver. Their maximum speed was 30 km/h; during the pilot their average speed was 12 km/h (Green et al., 2022). The shuttle’s level of driving automation according to SAE² was Level 3 (i.e. with a specially trained safety driver on board who can overtake the driving if a situation requires it). In automated mode, these shuttles follow a pre-defined trajectory. If the shuttle’s sensors detect anything within their safety zone (a defined space around the shuttle), the shuttle reacts according to the pre-programmed algorithms (typically by stopping or slowing down).

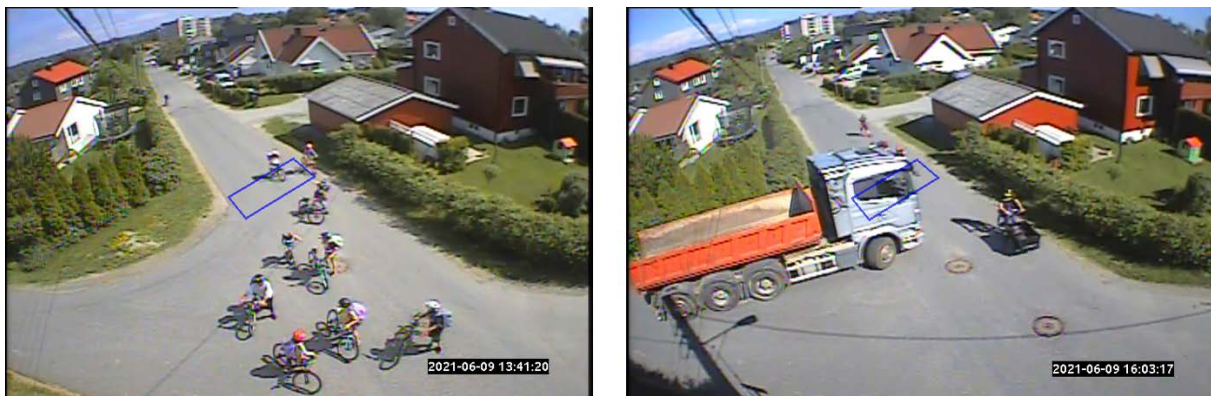
Figure 1.4: Examples of traffic in Hebekk.

With regards to the traffic regime, Hebekk is established as a 30km/h zone, with right-hand give-way rule on all the intersections inside the zone. There are no traffic signs and road markings in the area. The two-way roads are up to 5.0 m wide and there are no sidewalks along them. Thus, pedestrians and cyclists (often children and elderly) share the roads with motorised traffic (mostly passenger cars, sometimes a large vehicle appears). The motorized traffic volumes are not high. Family houses predominate in Hebekk, with many driveways into the properties. Furthermore, there is lot of greenery (and snow in winter) that might obstruct the drivers' views. Figure 1.4 shows two examples of the traffic in the area.

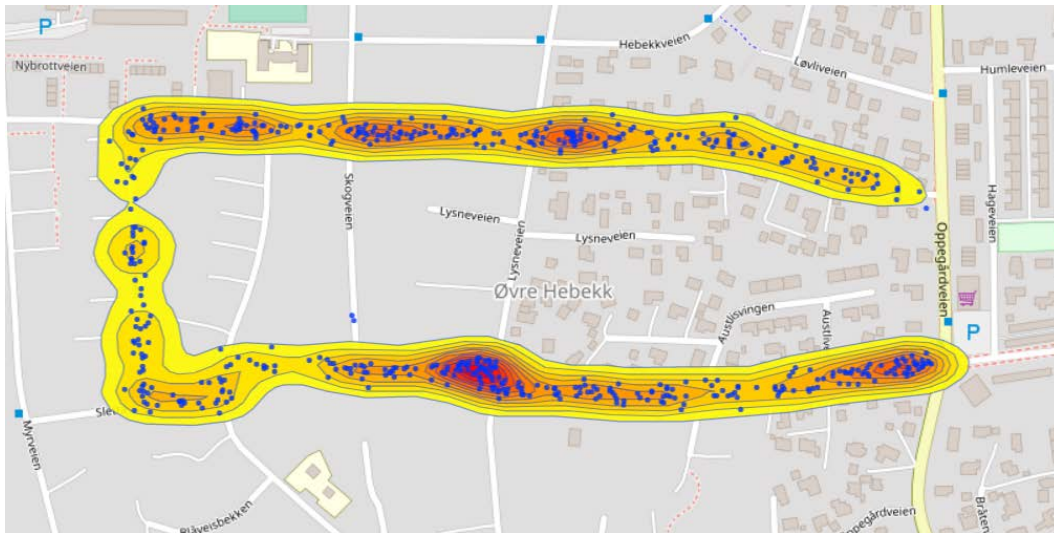
Figure 2.2: Heat map showing the locations where the shuttle stopped for a pedestrian (period 22/4 – 7/5/2021, source: Holo).

Locations #1 and #2 were selected based on the experiences of the shuttle drivers. On these locations, interactions with pedestrians were frequent. On location #3, the shuttle operator wanted to explore how the shuttle drives over the zebra crossing and enter the main road. Locations #4 and #5 were selected based on a heat map, which displays cases (recorded in the period 22/4 – 7/5/2021), in which the shuttle had to stop because of pedestrians walking in its proximity (Figure 2.2).

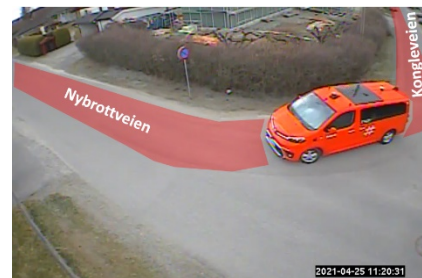
Location #1 - Nybrottveien x Kongleveien intersection

At this T-intersection, the shuttle was turning right from Kongleveien into Nybrottveien. Right-hand priority rule applies. Under uninfluenced conditions, the shuttle drove through the intersection smoothly, without stopping. Cars often park along the northern side of Nybrottveien.

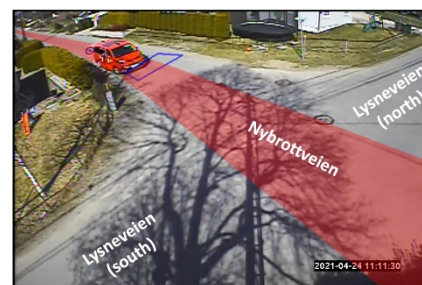
Location #2 - Nybrottveien x Lysneveien intersection

At this four-armed intersection, the shuttle drove straight along Nybrottveien. Right-hand priority rule applies. Under uninfluenced conditions, the shuttle drove through the intersection smoothly, without stopping.

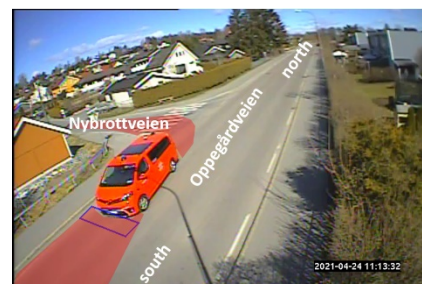
Location #3 - Nybrottveien x Oppegårdveien intersection

At this T-intersection, the shuttle was exiting the 30 km/h zone and entering the main road (Oppegårdveien). The main road has a 40 km/h speed limit and ADT around 3000 cars in both directions (according vegkart.atlas.vegvesen.no). There is a give-way traffic sign on the approach from Nybrottveien. Here the shuttle was turning right and should yield to vehicles coming from the left on the main road. There

is also a zebra pedestrian crossing across Nybrottveien. Under uninfluenced conditions, the shuttle usually slowly entered the intersection and turned right, without stopping.

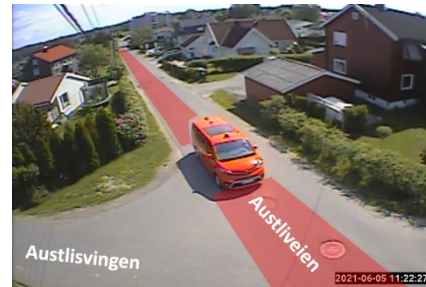
Location #4 – Austliveien

Here the shuttle drove straight along Austliveien, in a slight uphill (ca 5%), up to the intersection with Austlisvingen. This intersection is considered as a T-intersection⁴ in the analyses. There is a speed hump located in Austliveien. The road on this section is ca. 4,8 m wide. There are several driveways into the residential properties. Under uninfluenced conditions, the shuttle drove along the section and slightly slowed when entering the intersection with Austlisvingen.

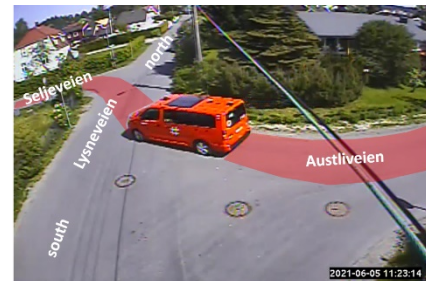
Location #5 - Austliveien x Lysneveien x Seljeveien intersection

At this staggered intersection, the shuttle turned right from Austliveien into Lysneveien and after ca. 20 m it turned left into Seljeveien. Right-hand yielding rule applies. Under uninfluenced conditions, the shuttle drove slowly through the intersection. For the analysis, this location was considered as two T-intersections.

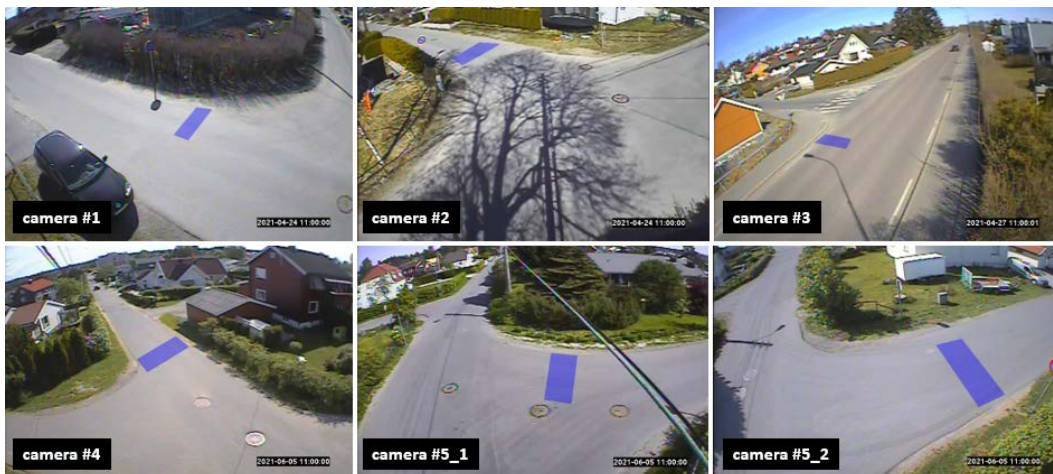
Figure 2.5: Shapes and positions of presence detectors in RUBA.

To detect the shuttle passages in the video, we used RUBA software⁵. RUBA gives the opportunity to create several types of detectors that detect moving objects in video. For our analysis, we prepared one presence detector for each recording. The positions and shapes of these detectors on all recordings are illustrated as blue rectangles in the pictures in Figure 2.5.

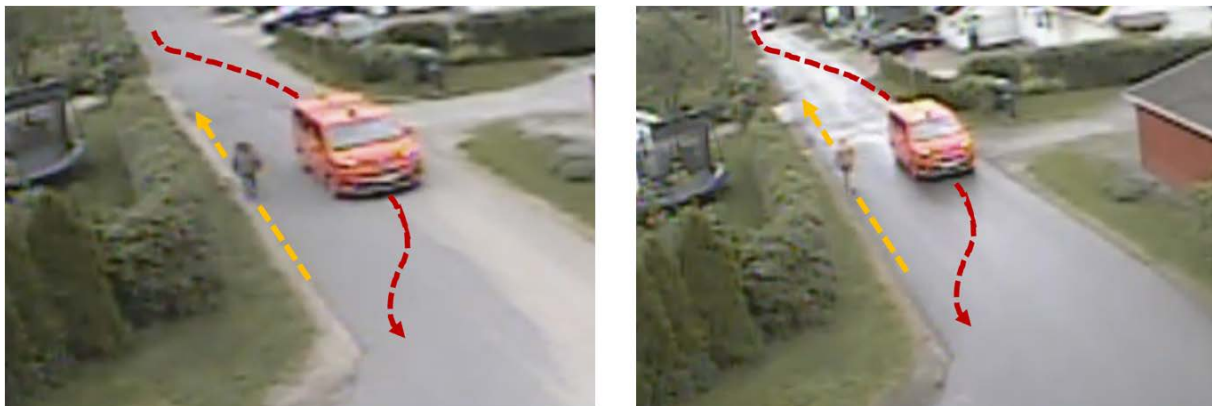
Most of the interactions involved a pedestrian, walking or standing on the right side of the road (at the same side as the shuttle was driving). In those situations the shuttle was in manual mode, because the shuttle drivers were instructed to proactively take over the driving in those situations (in order to avoid unnecessary stops). The shuttle drivers typically slowed down and drove around the pedestrian, keeping a significant lateral passing distance (Figure 3.2). When a pedestrian was on the left side of the road, the shuttle stayed in automated mode and continued to drive without slowing.

Figure 3.2: Examples of two situations at location #4 in which the shuttle (in manual mode) drives around a pedestrian (left – [clip #1](#), right – [clip #2](#)).

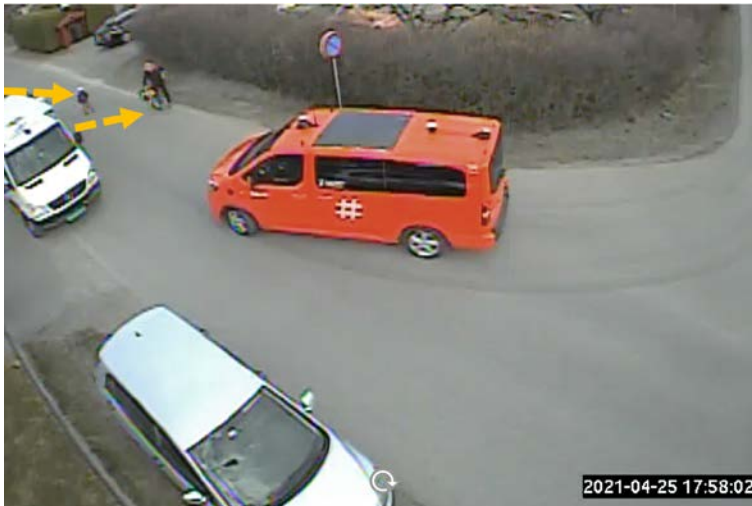
Regarding pedestrians, there was one situation that is worth highlighting, as it demonstrates the variability of scenarios that the shuttle might encounter in residential areas (Figure 3.3). In this situation on location #1, a kids' bike was lying in the middle of the road. When the shuttle was exiting the intersection, a man entered the road from the left, behind a parked car, to pick up the bike. A child entered the road as well. In this situation, the shuttle was probably in automated mode. It reacted well and stopped (hard).

Figure 3.3: Positions of pedestrians and the shuttle in the moment of the hard stop ([clip #3](#)).

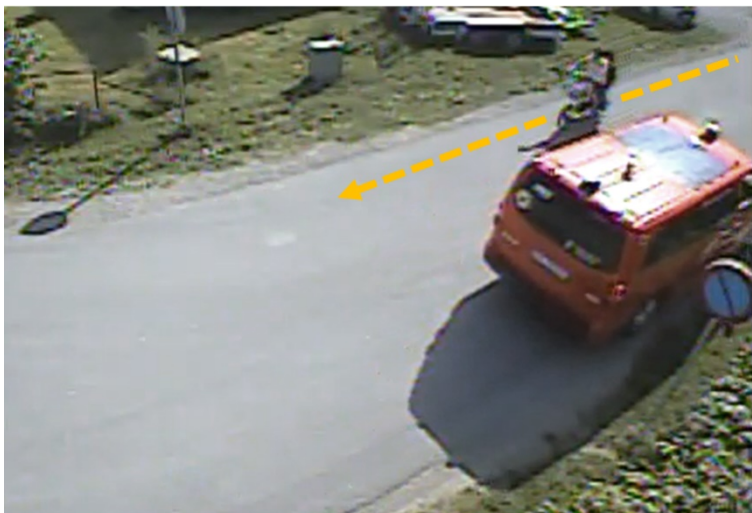
Regarding the situations involving vehicles (n=21), most of them were situations in which a vehicle was driving/was parked in the opposite direction. In those situations the shuttle did not react in any, except one, situation, in which it stopped because of a moped (location #5, Figure 3.4). In the situations involving a car parked on the right side of the road, the shuttle drove slowly around, probably in manual mode.

Figure 3.4: The shuttle (in automated mode) stops because of a moped riding in the opposite direction ([clip #4](#)).

There were seven inadequate reactions identified along the road sections. In four situations the shuttle stopped without a visible reason (3 x on location #1, once on location #3). In three other situations the shuttle (i) stopped after overtaking a parked car (location #1), (ii) the shuttle followed a pedestrian for a while (location #1) and (iii) the shuttle stopped because of a moped in the opposite direction (Figure 3.4).

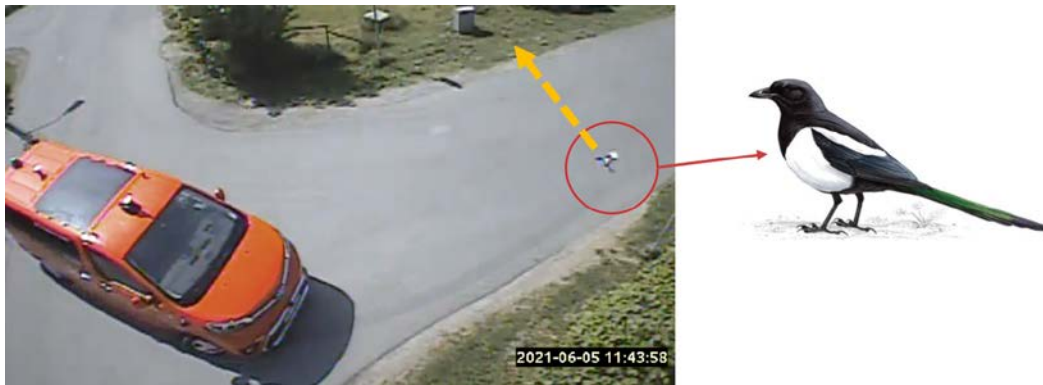
Sixteen reactions of the shuttle were evaluated as inadequate. Six of them were the stops without a visible reason; in one situation the shuttle reacted to a bird that crossed the shuttle’s trajectory (Figure 3.5).

Figure 3.5: The moment when the magpie crossed the shuttle trajectory ([clip #5](#)).

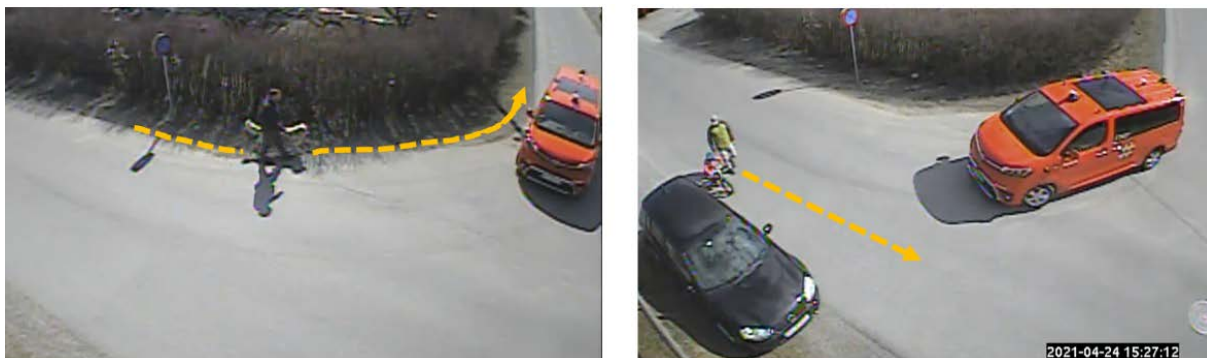
Three situations included a pedestrian. In one situation, the shuttle stopped when the pedestrian was walking along the left side of the road (location #1, Figure 3.6 - left). The other situation involved a child and a man who were walking close to the middle of the road. There was a parked car on the left side of the road as well (location #1, Figure 3.6 - right). The shuttle detected them and stopped hard. This reaction was on the border between adequate and inadequate, as it provided a comfortable/safe space for pedestrians, but the braking was very hard and thus uncomfortable to any passengers inside the shuttle.

Figure 3.6: Positions of pedestrians and the shuttle in the moment of the hard stop (left: [clip #6](#); right: [clip #7](#)).

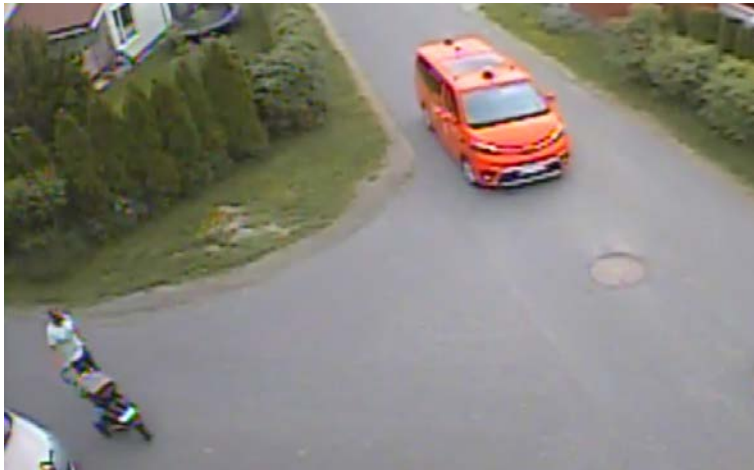
In the third situation, the shuttle stopped too early to give way to the pedestrian from the right (location #4, Figure 3.7). It seemed that the shuttle driver took over the driving to solve the situation.

Figure 3.7: In this moment the shuttle has been already stopped for five seconds and the driver took over driving ([clip #8](#)).

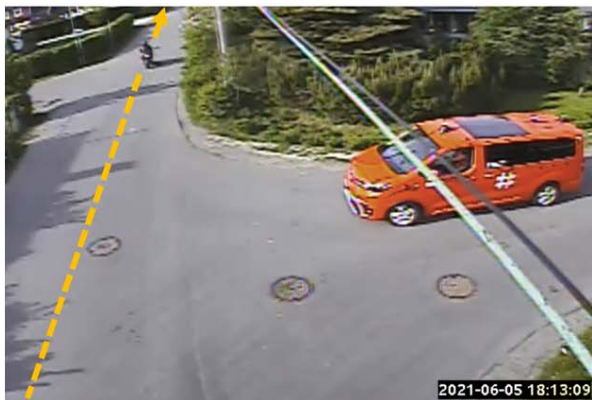
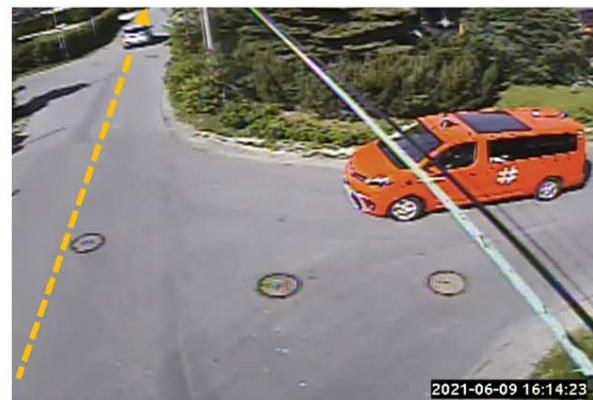
Six inadequate reactions involved a motorised vehicle. All were observed on location #5. In three situations the vehicle was approaching from left and the shuttle was turning right. In two of those, a motorcycle and a passenger car had already driven through the intersection, but the shuttle stopped anyway (ca. five seconds after the vehicle drove away). These reactions were classified as unnecessary, delayed stops (Figure 3.8). In the third situation, the car from the left did not give way to the shuttle, the shuttle stopped and stayed stopped for ca 20 seconds (too long stop).

Figure 3.8: The positions of the shuttle and motorised vehicles in the moment of the shuttle's reaction (left: [clip #9](#); right: [clip #10](#)).

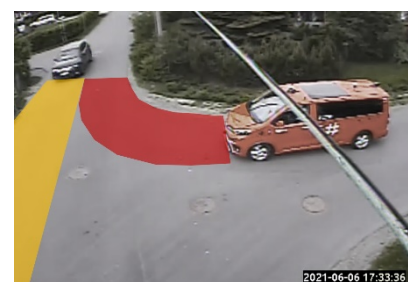
In three situations, a vehicle was approaching from the right. These were not “give way” situations, as the shuttle was turning right. However, the relatively narrow road required careful maneuvering (Figure 3.9). In two of these situations the shuttle stopped on the approach (Figure 3.10). This was a correct reaction, however the stops were hard and therefore classified as inadequate.

Figure 3.9: Scheme of the situation.

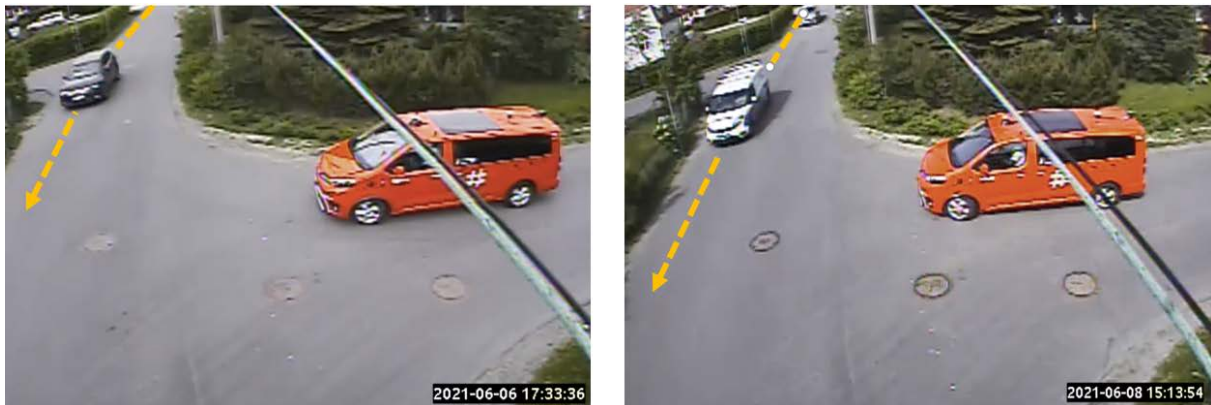
Figure 3.10: The positions of the shuttle and cars in the moment of the shuttle's reaction (left: [clip #11](#); right: [clip #12](#)).

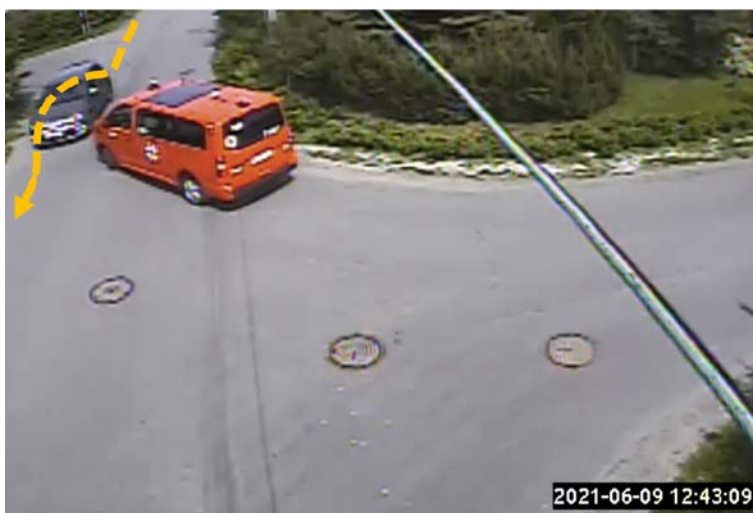
In the third situation, the shuttle entered the intersection despite a car approaching from the right. After detecting the car, the shuttle stopped inside the intersection (and stayed stopped for 12 seconds) and the car made a slight avoidance maneuver. This situation was classified as a conflict (Figure 3.11).

Figure 3.11: Positions of the car and the shuttle, when the shuttle stopped ([clip #13](#)).

From the 40 inadequate reactions, one was categorised as a conflict caused by the shuttle (Figure 3.11).

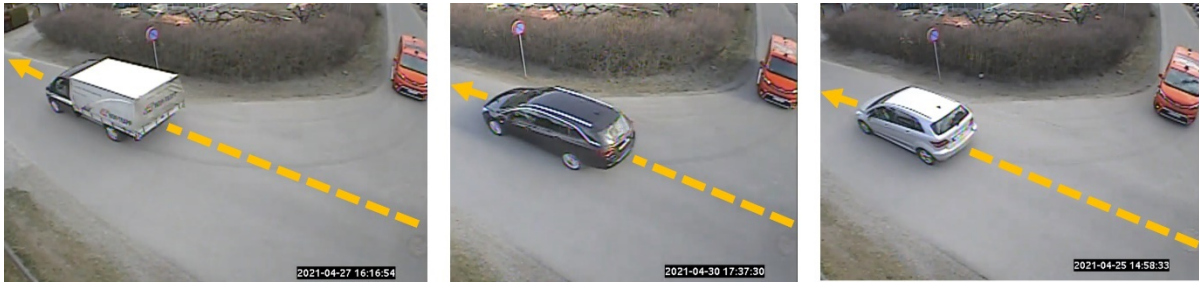
From 11 give-way situations with a car driving from the left and continuing straight, we observed eight situations in which the car drivers were not giving way to the shuttle. Three such situations were observed on location #1 (Figure 3.12) and five on location #5. In all these situations, the cars should have yielded to the shuttle according to the right-hand yielding rule. In all situations, the shuttle stopped hard. In two situations the cars were clearly accelerating to avoid giving way. In several situations, the cars have already been exiting the intersection at the moment the shuttle stops. We did not consider such stops as inadequate, because they were triggered by illegal behaviour of the car drivers.

Figure 3.12: Positions of cars and the shuttle in the moment of the hard stop of the shuttle (from left: clips #14; #15 and #16).

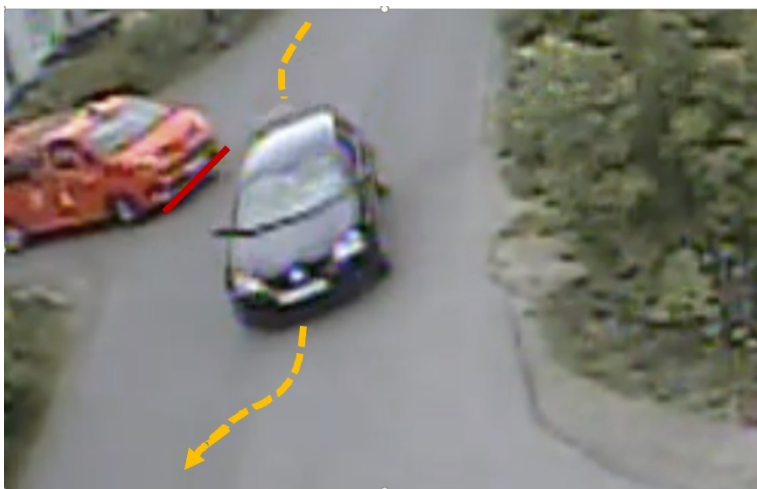
One of situations on location #5 was considered as a conflict, as the shuttle had to stop hard to avoid crashing with the car. The car also made an evasive maneuver (Figure 3.13).

Figure 3.13: Positions of the car and the shuttle, when the shuttle stopped (clip #17).

From a safety perspective, the most disturbing finding refers to the fact that we observed several car drivers not giving way to the shuttle at the intersections with right-hand yielding rule. In 17 give-way interactions between the shuttle and a car, we observed 9 situations (53 %) in which drivers did not give way to the shuttle. One of these situations was considered as a conflict, as the shuttle had to stop hard to avoid crashing into the car. The car also made an evasive maneuver (Figure 3.13).

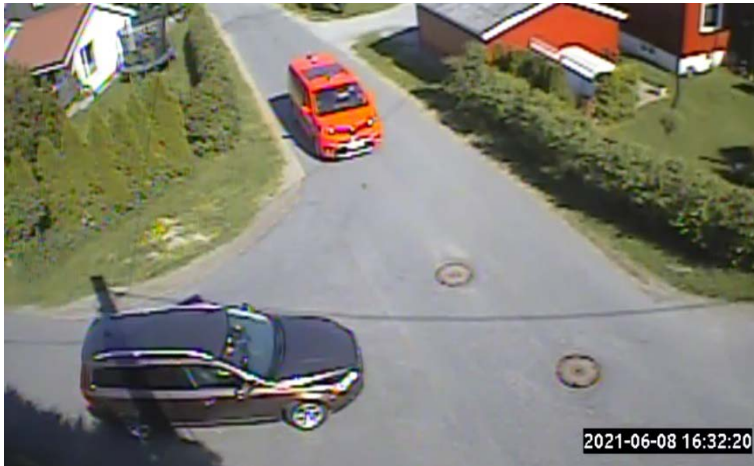
When the shuttle was supposed to give way, the shuttle did so. In one situation, on location #4, both the shuttle and the car stopped and the car drove first after a while. This was classified as “stale-mate” situation (Figure 3.14).

Figure 3.14: “Stalemate” situation – both vehicles have stopped ([clip #18](#)).

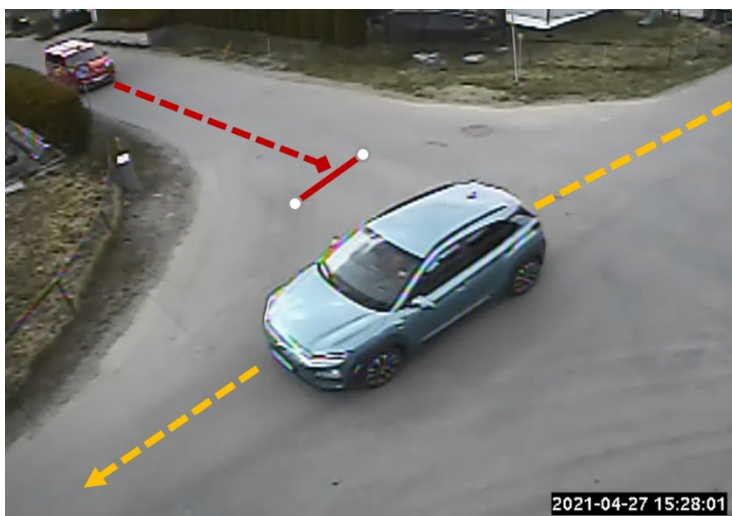
Nine reactions by the shuttle were evaluated as inadequate. Seven involved a motorised vehicle, one involved a pedestrian and one situation involved only the shuttle. In situations involving motorised vehicles, four reactions were delayed stops (by ca. 4-5 seconds) as a late reaction to a vehicle from the left that had already exited the intersection (such as the one on Figure 3.15).

Figure 3.15: Positions of a car and the shuttle 4 seconds before the shuttle stops ([clip #19](#)).

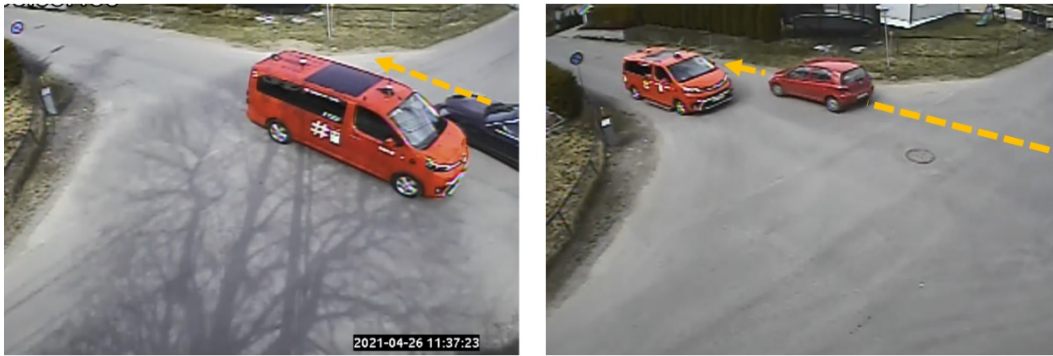
In two situations, the shuttle stopped during a passing interaction with vehicles in the opposite direction. The vehicles were probably inside the shuttle's safety zone, however there was still enough space to drive. One stop occurred in the middle of the intersection, another on the approach (Figure 3.16).

Figure 3.16: Moments of stops in passing situations (left: [clip #20](#); right: [clip #21](#)).

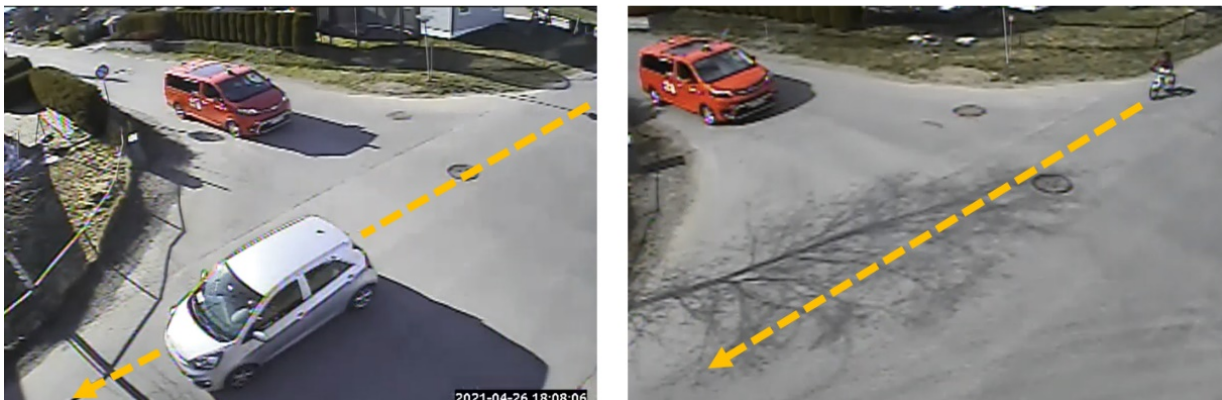
There were four situations (one with a car, one with a child on a bike and two with pedestrians) in which the shuttle had the right of way but had to stop, because the other road user did not give way to the shuttle (Figure 3.17). The situation with the child on the bike ([clip #23](#)) might be considered as “stale-mate “ situation, as both the shuttle and the child slowed down and the child decided to continue once the shuttle stopped.

Figure 3.17: Positions of the shuttle and the other road users in the moment when the shuttle stopped (left: [clip #22](#); right: [clip #23](#)).

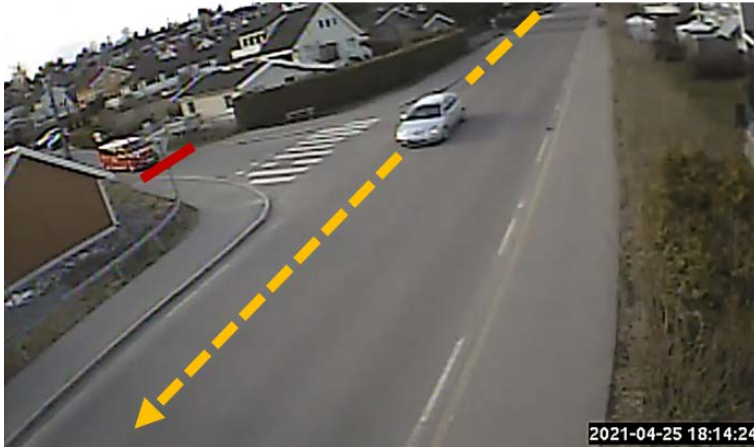
Eight reactions of the shuttle were evaluated as inadequate (six with a passenger car, one with a bike and one with a pedestrian). In situations involving passenger cars (all driving from the left) the shuttle stopped very hard in five situations and in one situation the shuttle stopped too early (Figure 3.18).

Figure 3.18: The shuttle stops too early/unnecessary when giving way to passing car. Position of shuttle and car when the shuttle stops ([clip #24](#)).
